Integrated Rehabilitation
Project Plan
Survey of the Architectural
and Archaeological Heritage

Prioritised
Intervention
List

KOSOVO*

Document adopted by the
Ministry of Culture, Youth and Sport of Kosovo
on 23 January 2009

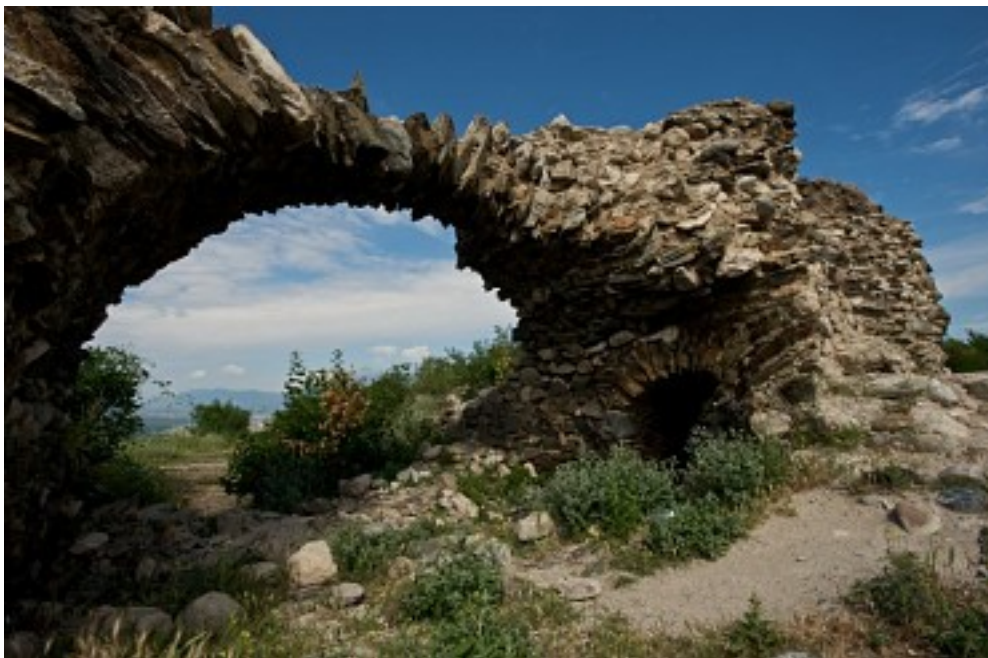
The Fortress - Prizren (KO_01)

Very bad: the walls are partially destroyed, parts of the ensemble within the walls are decayed and the access to the fortress is very bad.

Since the object is constantly affected by moisture, the remains of the walls are exposed to the greatest risk of continuous deterioration.

Immediate risk: continuous destruction from moisture and neglect.

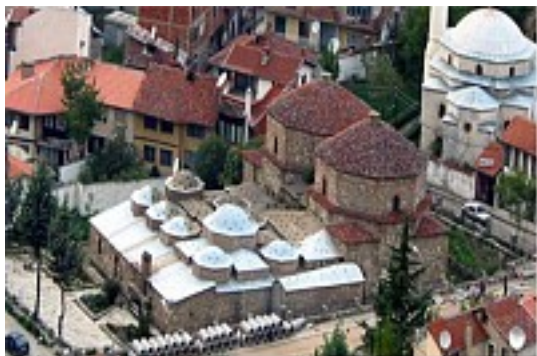
The Hammam of Gazi Mehmed Pasha – Prizren (KO_02)

Poor: because of water infiltration through the roof, the floor, walls and cupolas are partly damaged.

Immediate risk: except the main cupolas, the condition of the roof is alarming. There are photographic records of the existing condition.

Slow decay: The floor is continuously damaged by moisture and visitors.

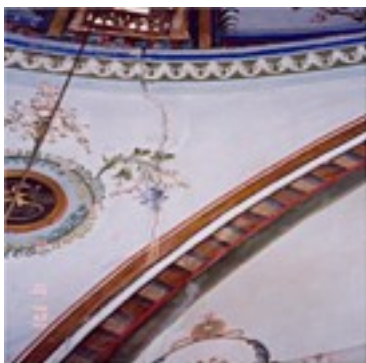
Jashar Pasha Mosque - Prishtinë/Priština (KO_03)

Poor: The condition of the Jashar Pasha Mosque is not good. There are cracks in construction elements and the condition of the stone is not good. The historical environment is degrading.

The Mosque is exposed to gradual decay. The Mosque is situated close to the main street. The constant traffic affects the stability of the monument. Repair measures were carried out without preliminary studies.

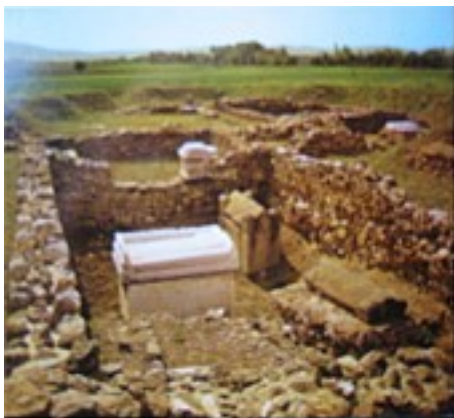
Ulpiana – Justiniana Secunda archaeological site - Gracanica (KO_05)

Very bad: condition of discovered antique remains: walls of the Northern Memory, marble sarcophagus and three other sarcophaguses are damaged because of lack of conservation measures and are in poor conservation state. Objects discovered in 1955, along the 'decumano maximus', the surrounding wall and a worship place are not conserved. The worship place in the western part of the ancient town is not conserved.

Good condition: Walls of ancient monuments of the Northern Portal and Justinian's Basilica are in good condition, but there is a need for interventions due to slippery stones of the walls and damages from the vegetation.

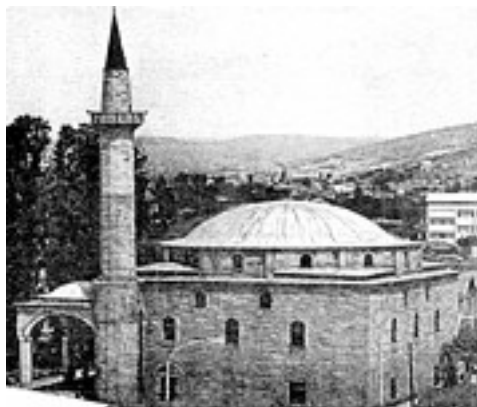
Sultan Mehmet Fatih Mosque – Prishtinë/Priština (KO_07)

Poor: the state of conservation of the Sultan Fatih Mosque is poor. There are cracks in construction elements and the stone condition is not good.

The Mosque is exposed to gradual decay. It is situated near the main street, and affected by the constant traffic which results in decay. Some measures and repairs were undertaken, but without being first examined and studied. Remedial works are being carried out under the aegis of the government of Turkey, but there has been no historical analysis and no long term programming of works.

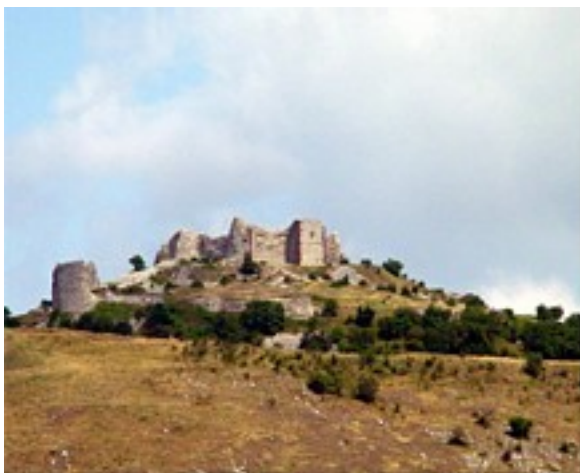
The Fortress of Gumnishte/ Historic Novo Brdo (KO_08)

Very bad condition – the antique city, the mediaeval upper city and lower city, where the walls have almost collapsed, the foundations of the Saxon church, structural problems (foundations), stones have slipped so it is hard to notice the church plan. The small church, discovered in 1951: structural foundation problems.

Good condition - the foundation of the Good Friday cathedral and of the church with surrounding walls, discovered and preserved in 2003.

Immediate risk of further deterioration, solution found but not implemented.

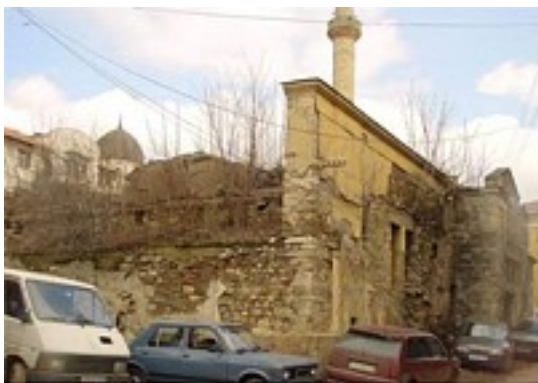
The Great Turkish Baths – Prishtinë/Priština (KO_09)

Vegetation on the roof that was causing structural failure has been cleared. The lobby is still in very poor structural condition, and the wall paintings in poor repair. Consolidation work has started.

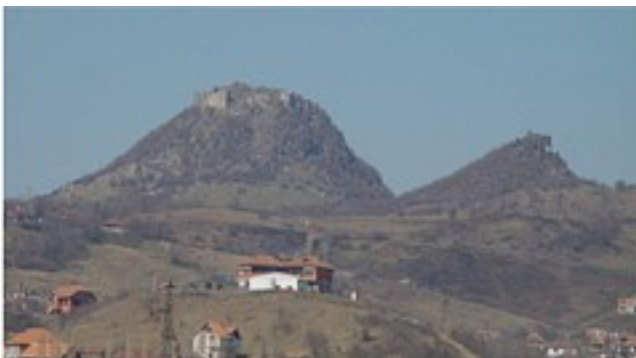
Fortress - Zvečan /Zvečan (KO_11)

Very bad: severe deterioration of walls surrounding the castle and of archaeological remains within the walls.
